## HC-Sinus Slide® Joints for lasting repairs in industrial floors

## 1. HC-Sinus Slide® repairs with jointing system

## 2. HC-Sinus Slide® Repair joint without load transfer system

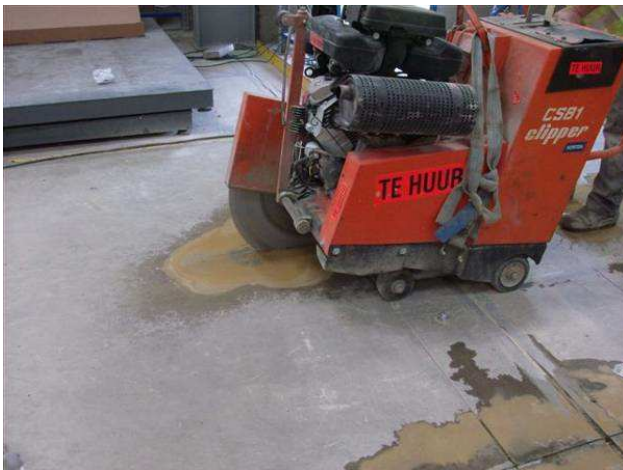
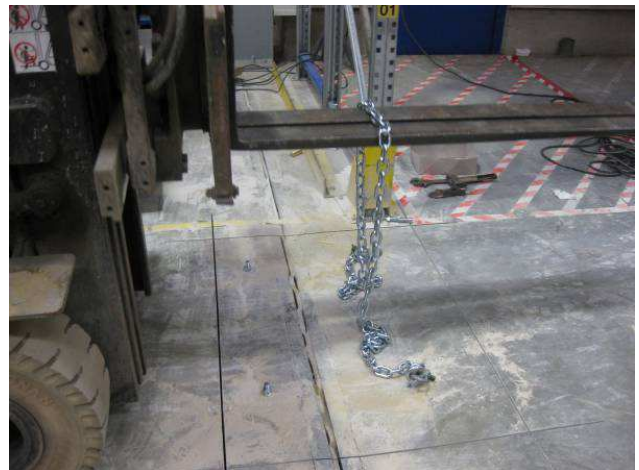
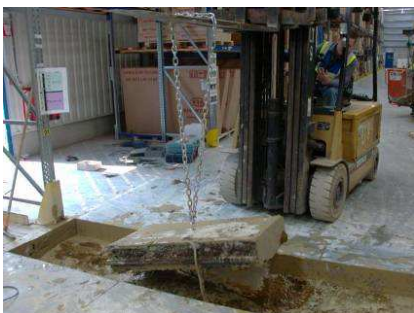
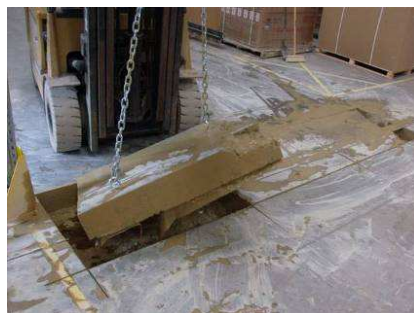
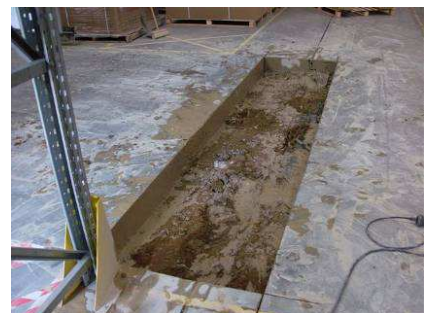
**Saw-cut the concrete full depth on both sides of the damaged joint on a width of approximately 800 to 1000 mm. Remove carefully the concrete and re-level and re-compact the sub-base material.**

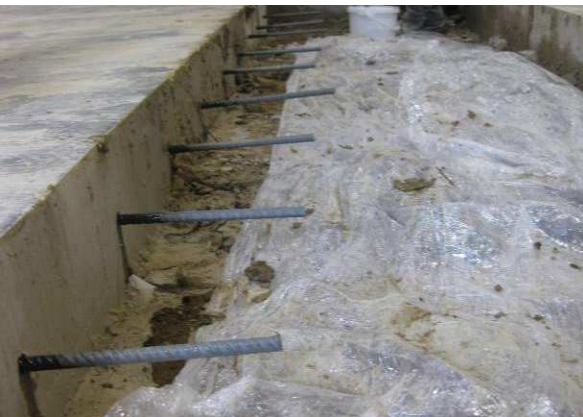
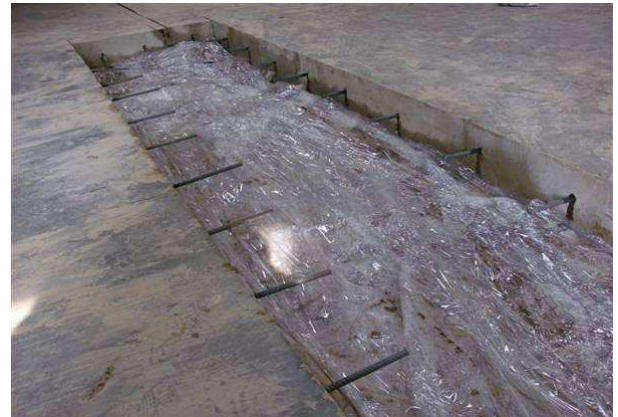
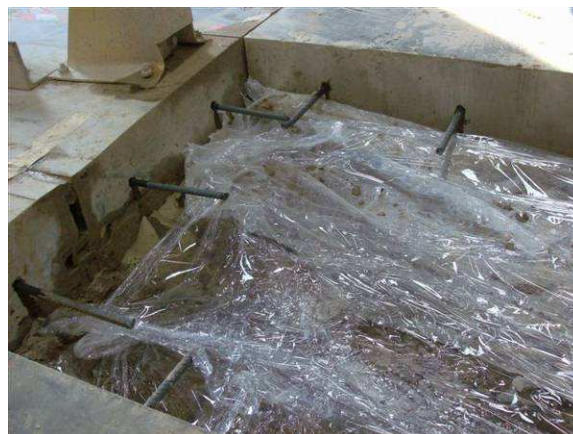
Then drill and fix deformed bars ( $\varnothing 16 \times 600$  length) in each concrete slab. At least 3 dowels per meter in each concrete slab. 300 mm of the dowel must be fixed in the concrete (ideally with resin anchorage system) and 300 mm must stick out. Apply special primer on all vertical sides of the concrete slab.

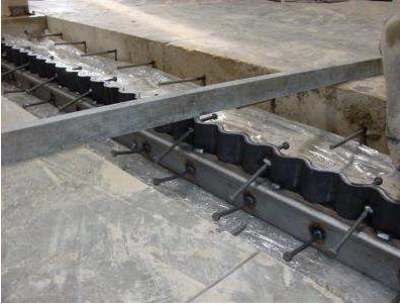
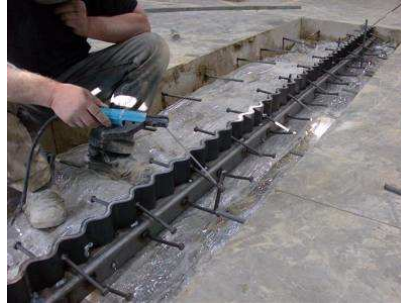
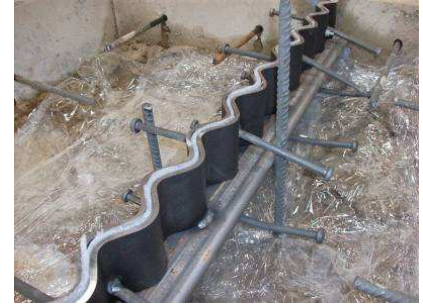
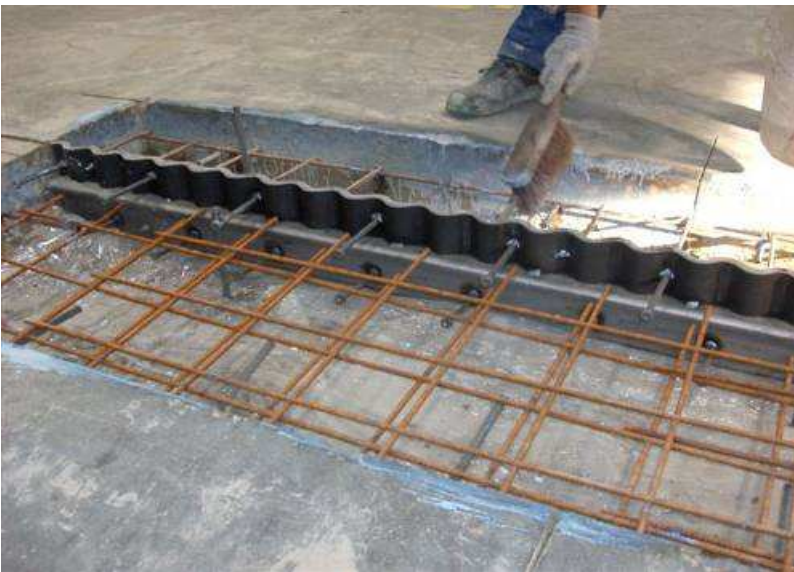
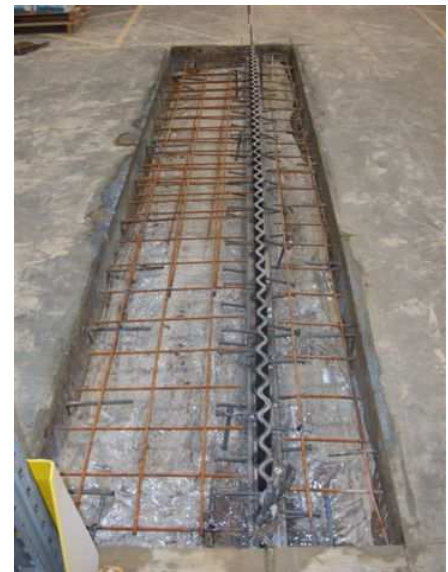
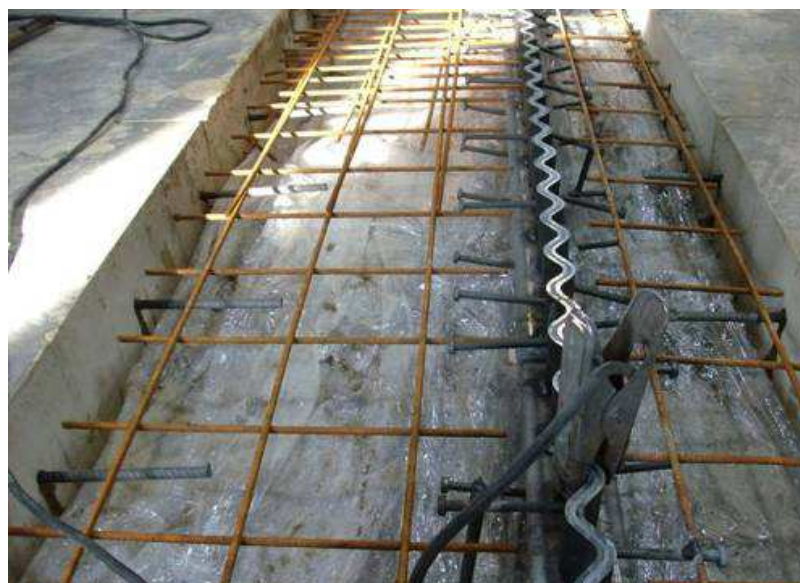
Install a HC Sinus Slide® joint in the middle of the gap opening between the concrete slabs. Level out the HC Sinus Slide® joints down and across. Eventually, weld the dowels fixed in the concrete slabs to the anchorage system of the HC Sinus Slide joint or use reinforcing mesh to link dowels and joint connectors.

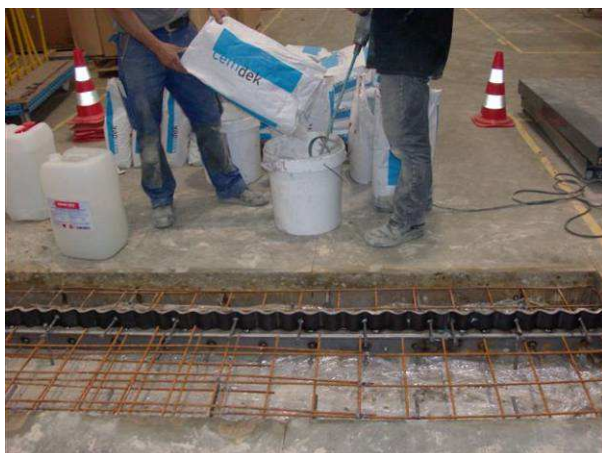
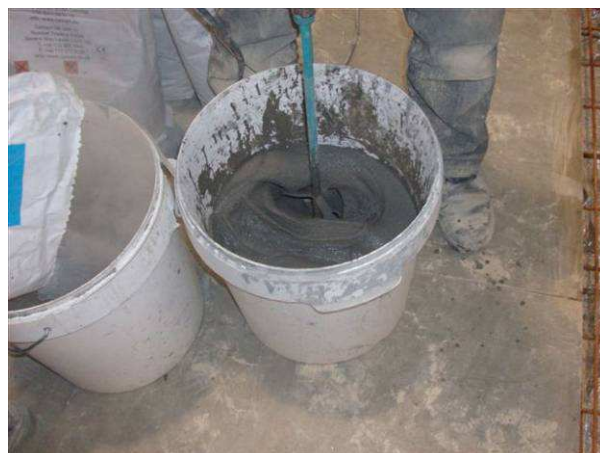
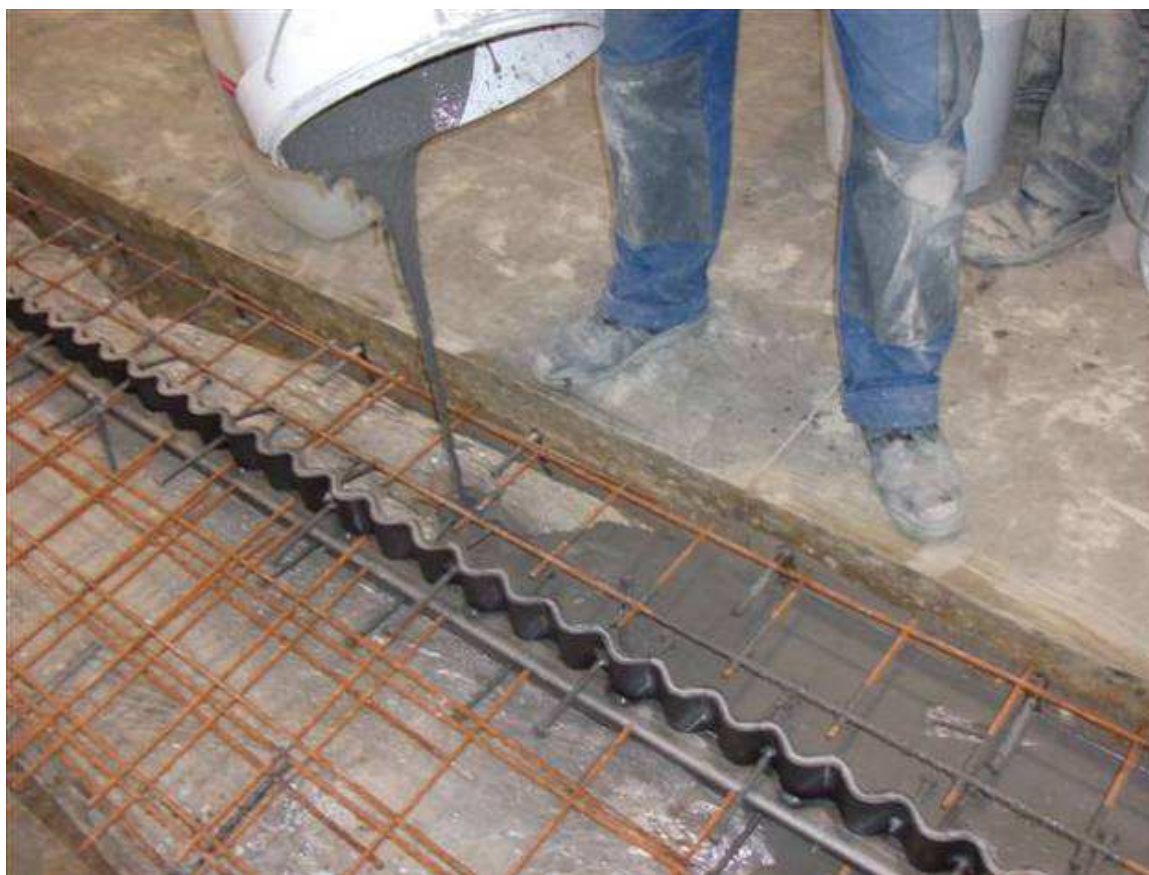
Fill up the opening gap with (reinforced) concrete or special repair mortar. Finish the floor by polishing and/or grinding. It is recommended to use a HC Sinus Slide® joint with minimum 5 mm foam in-between the 2 half's to permit a horizontal movement in the two directions in case of extreme temperature changes. This repaired jointing system with sliding capacity will realise optimal smooth load transfers by 100% shock- and even vibration free wheel crossings. Future damage is almost impossible and unprecedented comfort is achieved. Yearly savings on forklifts wheels maintenance or replacement are substantial.

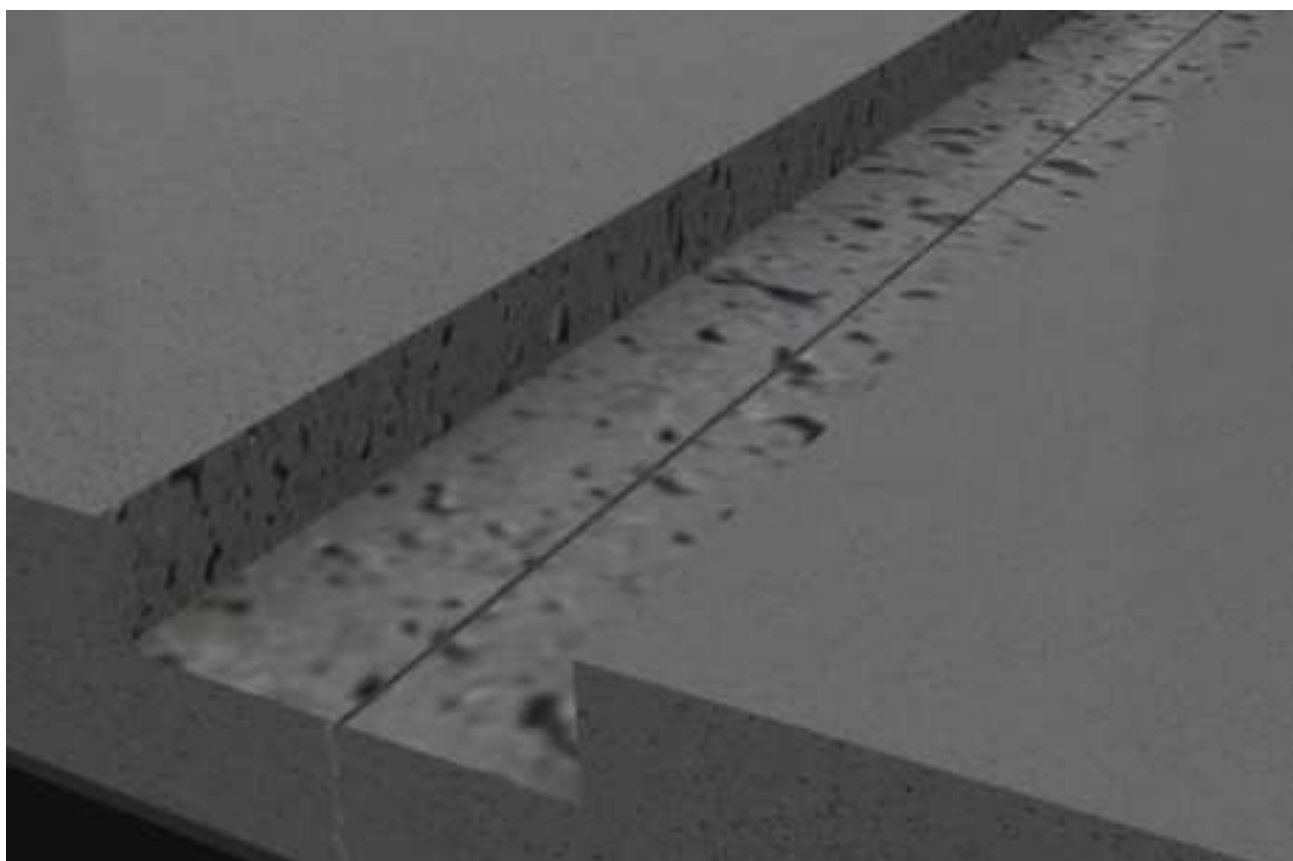
Saw-cut away the concrete on both sides of the damaged joint to a width of approximately 100 to 150 mm and a depth between 40 and 100 mm in function of the accessed damage.

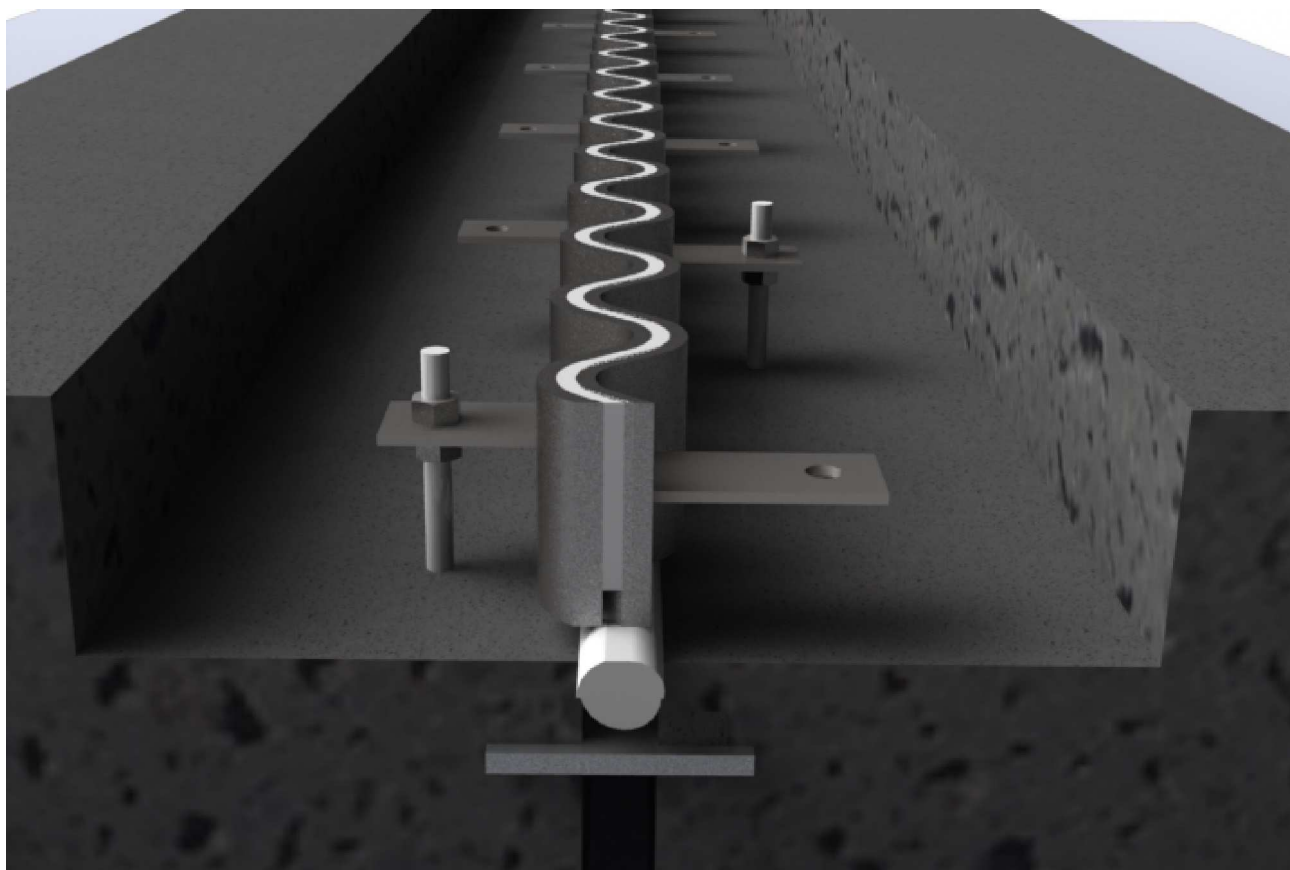
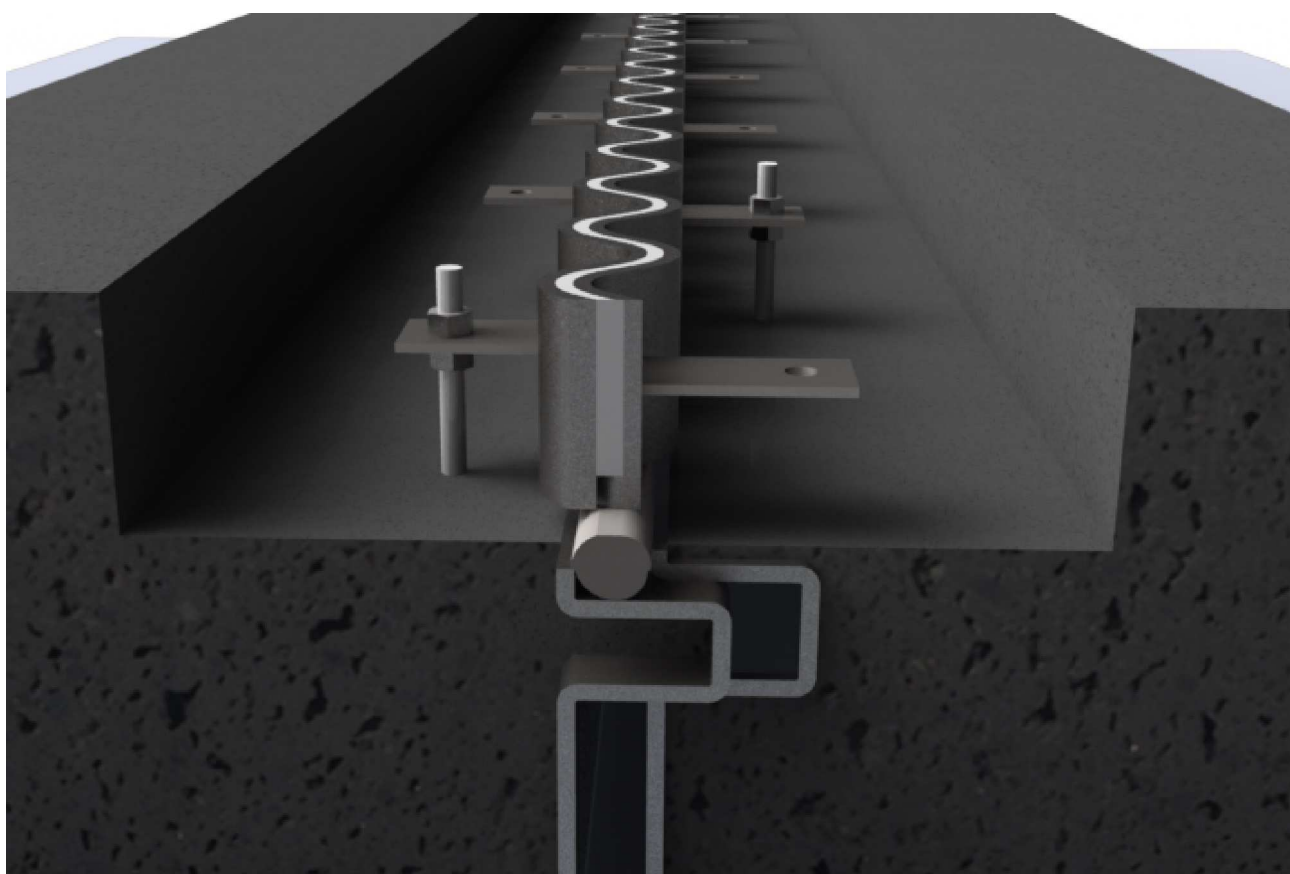
Apply a special primer on all sides of the concrete slab for good adhesion of filling material. Drill some holes in the concrete bottom positioned at the same distance as the anchorage of the HC-Sinus Slide® repair joint. Install screwed rod through the anchorage openings and fix into the drilled holes. Level out the HC Sinus Slide® joints down and across.

Fill up the opening gap with (reinforced) concrete or special repair concrete and finish the floor by polishing as soon as possible.
